**Downtown Stadium Tax Increment Financing Plan**  
Kansas City, MO, 64108

**Report Date**  
September 8, 2026

Subject: Existing Conditions Study  
Downtown Stadium Tax Increment Financing Plan  
Kansas City, MO 64108  
Partner Project No. 26-606796.1

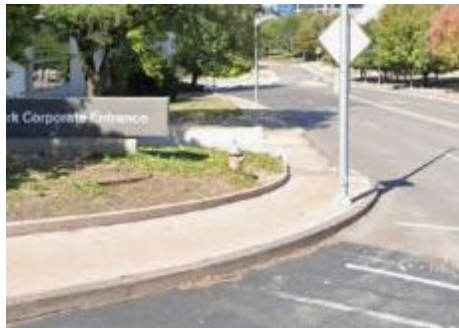
| | | | <p>Site lines looking north on Gillham Rd to E Pershing Rd from Hallmark Corporate Entrance are unsafe. This unsafe condition is exacerbated by the intersection immediately north and described below.</p> |

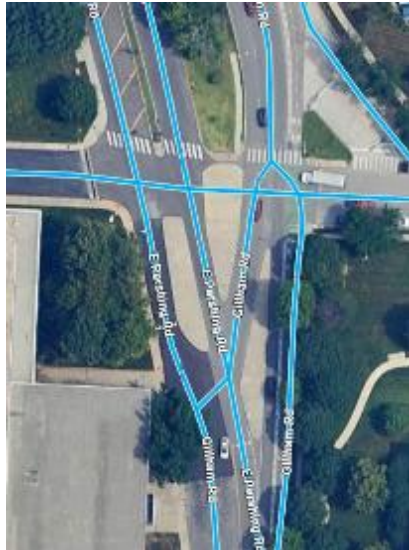
| | | | <p>Within the public rights-of-way is the dangerous transition from E Pershing southbound to Gillham Rd southbound. Gillham intersects with northbound East Pershing Road at Crown Center's 25<sup>th</sup> Street Entrance. The only traffic control is a yield sign for northbound E Pershing Rd. This is an unsafe intersection for automobiles, bicycles/scooters, and pedestrians.</p> |

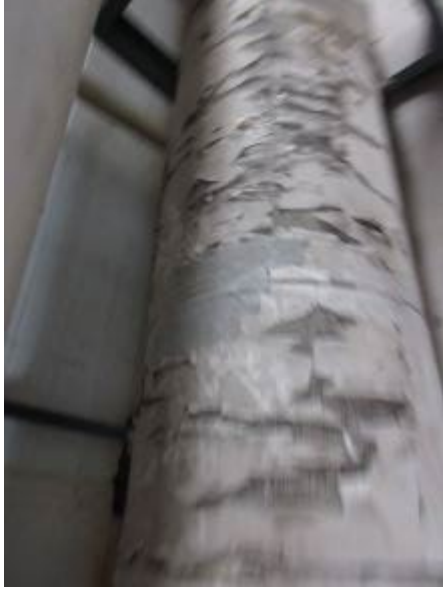
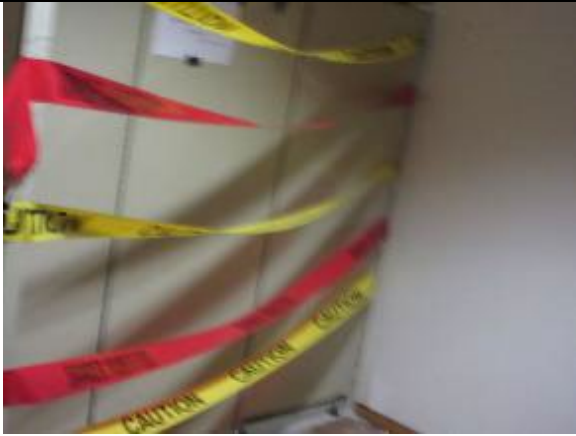
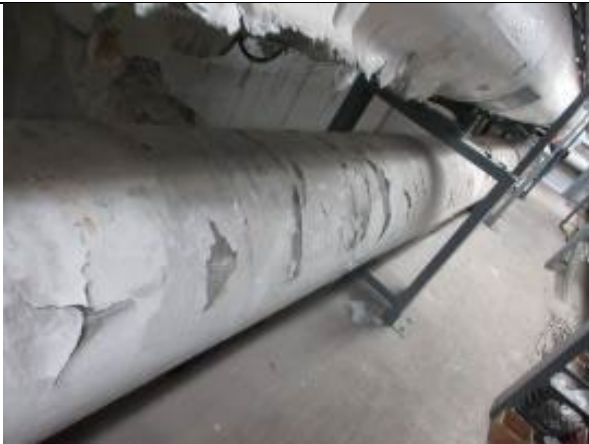
There are several instances of asbestos yet to be encapsulated or removed in the older buildings and utility corridors. These are infrequent but known and impair the area and are considered unsafe and insanitary conditions.

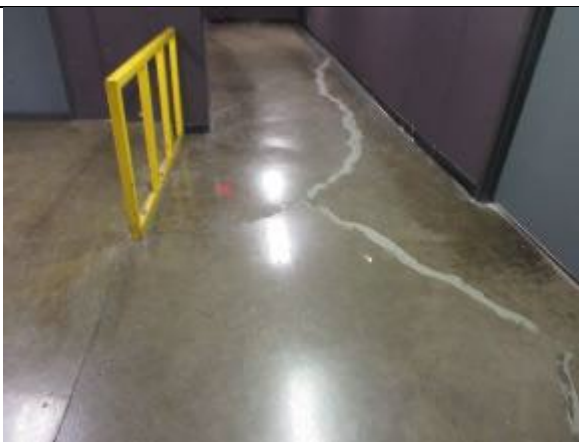
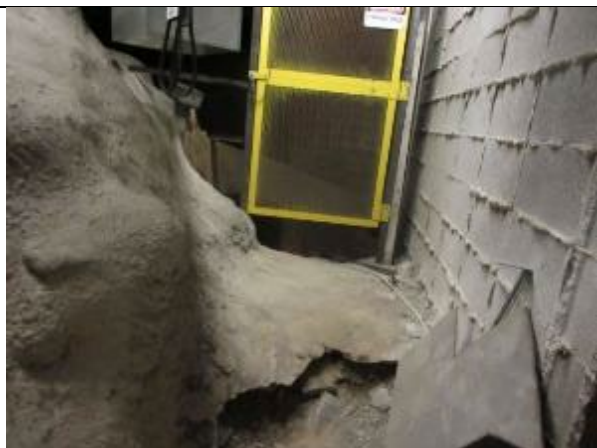
The Headquarters Building BD is built into the existing hillside and the limestone comprises part of the building structure and the site improvements. The continual and chronic heaving creates uneven floors, doors that will not operate properly and can collapse utility conduits including plumbing. There can be a safety risk to the Hallmark employees and visitors and repeated exposure to the surrounding soil and limestone is an insanitary or unsafe condition as well.

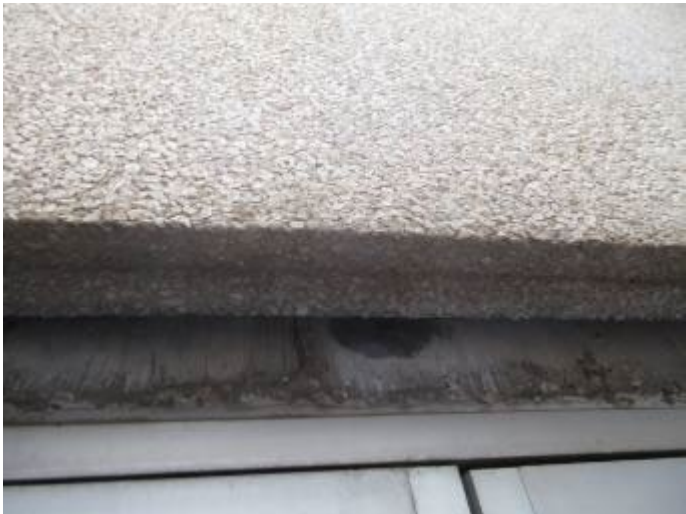
| | | Deterioration of the concrete roof of the garage structure which is part of the infrastructure and at grade in Crown Center Square. |

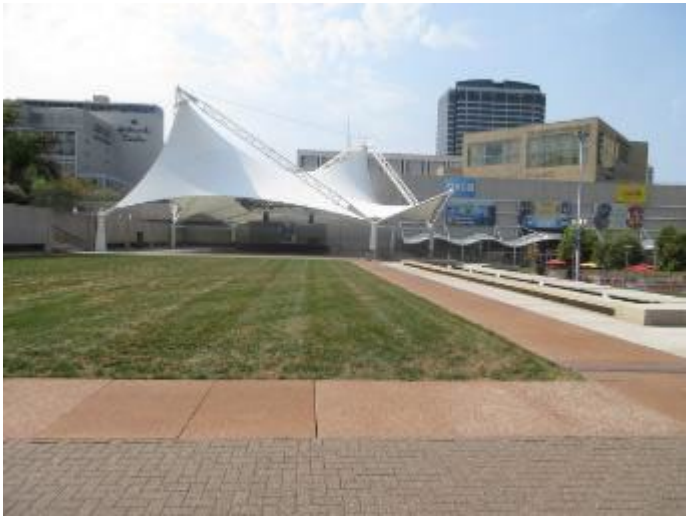
| | <p>Nearly all of Crown Center’s landscaping and hardscaping is built over parking garages. The membranes and drainage system require continual maintenance and capital improvement. Much of the deterioration is unobservable until a condition becomes critical which is a frequent occurrence.</p> |
| | <p>Numerous fountains are in disrepair and contribute to the drainage and membrane issues affecting the garage roofs and the surface improvements.</p> |
| | <p>Crown Center’s capital needs program identifies \$13.3 million, short term, for capital investment to maintain the membranes and drainage. Deterioration causes operating expenses and capital expenditures are significantly more any other project in the Kansas City area.</p> |

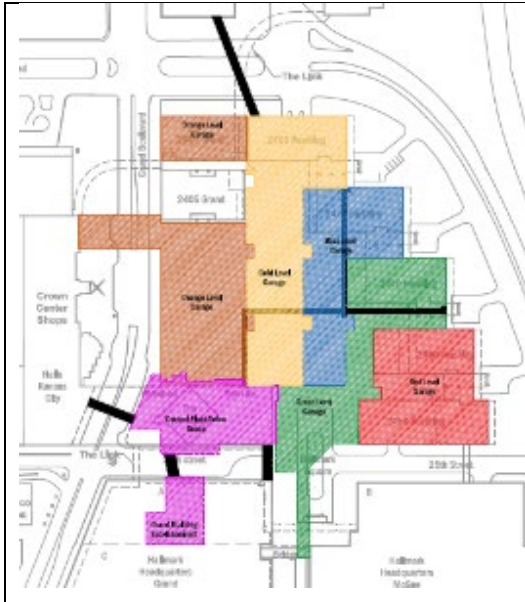
There are many instances where site improvements of one building or parcel intersect with neighboring building improvements. This is due to the multi-level development of Hallmark and Crown Center over the last 50+ years. This is exacerbated by the utility corridors which provide power, heat, cooling and water to nearly all buildings from the central power plant.

The central plant was constructed in 1971. That specific building is not within the area studied for blight, however, the utility corridors from it are of similar vintage and included in the blight study area. These corridors represent site improvements experiencing deterioration and exhibiting unsafe conditions.

The infrastructure emanating from the central plant deteriorates continually. I estimate there is nearly ½ mile of utility corridor between and above, at or below street grade between the nine parcels comprising the blight study area. There is significant deterioration at various locations within these corridors as represented in the photographs to the left.

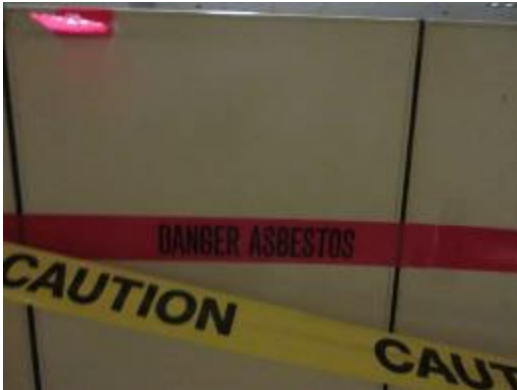
The small and expected presence of asbestos and the unsafe design of evacuation are evidence of a danger to life and property. Here the presence of asbestos in Building AC is identified and prohibited from interruption as shown in the photo to the left. Below is a directional sign posted in a stairwell in Building BD where habit and intuition suggests an employee or visitor would go up the stairs in the event of an evacuation yet the directional sign is to go down the stairs. I have included another example of posted evacuation instructions each confusing and not intuitive and a danger to life and property.

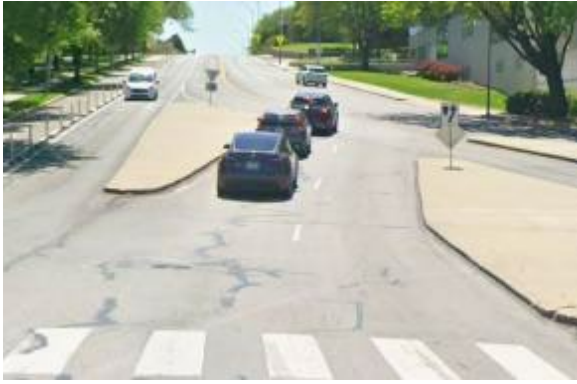
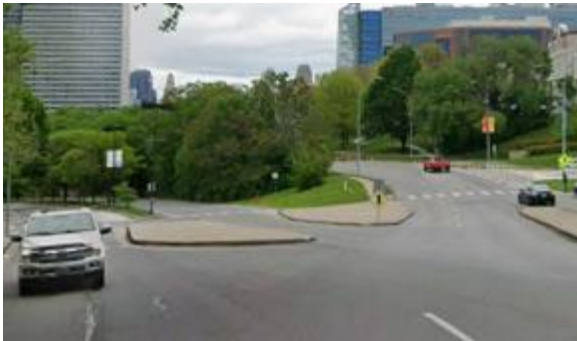
The intersection of E 25<sup>th</sup> Street, Gillham Road, and E Pershing Road is a danger to life and property. The intersection has Gillham Road maintaining its north south route at 25<sup>th</sup> Street while diverging completely to E Pershing Road also north to south. In this instance southbound E Pershing must merge with southbound Gillham Road and northbound E Pershing must exit across southbound Gillham Road where the only traffic control is a yield sign. All of this while there is two way traffic on 25th Street. Eastbound E 25<sup>th</sup> Street will cross two lanes of traffic.

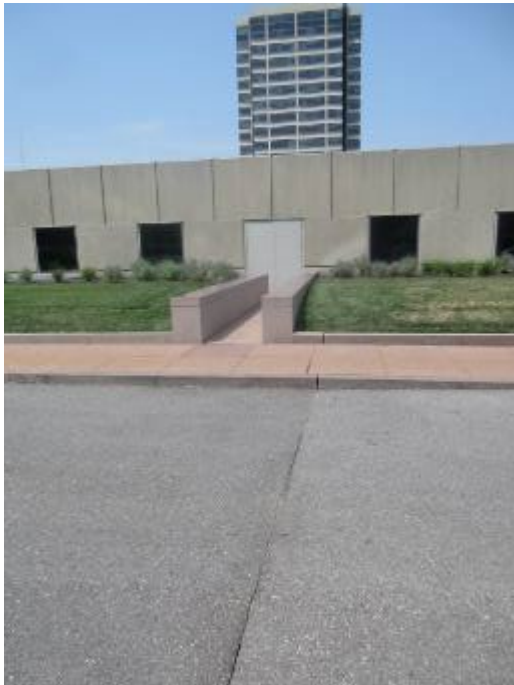
The image on the left is facing west from the Headquarters BD toward the Shook Hardy Bacon office building. The view is of the eighth floor which is at grade on the east elevation. The image below is facing southwest between the Headquarters BD (left) and Warehouse AC. On the left I show the ground level/1<sup>st</sup> floor of the eight story BD Building. Within these two buildings, a developer converting to multifamily would lose over 50% of the gross building area to unproductive common area.

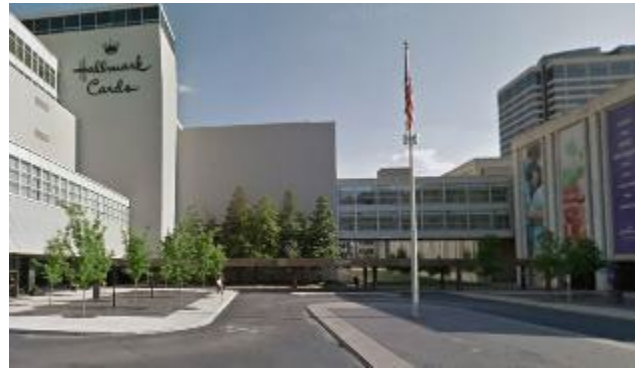
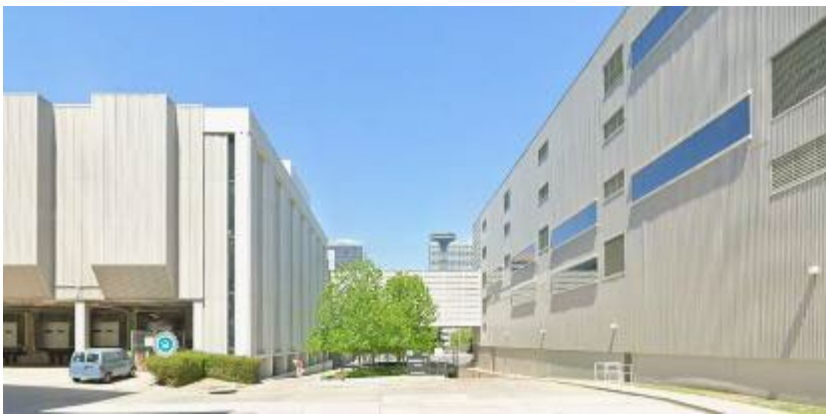
Facing north between BD (right) and AC, along McGee. Even a convenient and well suited building footprint will not overcome the other aspects of the area which is inappropriate for housing such as the inability to provide utilities in a feasible manner, the near absence of windows, and the distance between elevator lobbies.

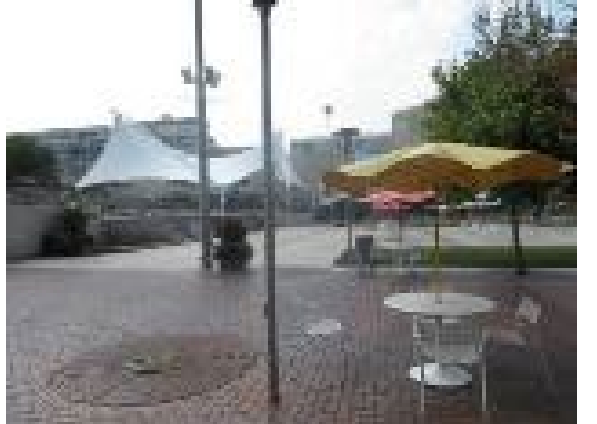
| <p>The extensive infrastructure of the parking garages below grade prohibits significant disturbance of the surface as would be necessary for the addition of residential development. Exceedingly high expenses and the complicated deterioration of said site improvements would increase significantly with the addition of or change in use to residential.</p> | | | | | | | | | | | | | | | | | | | | | | | | | | | | | | | | | | | | |

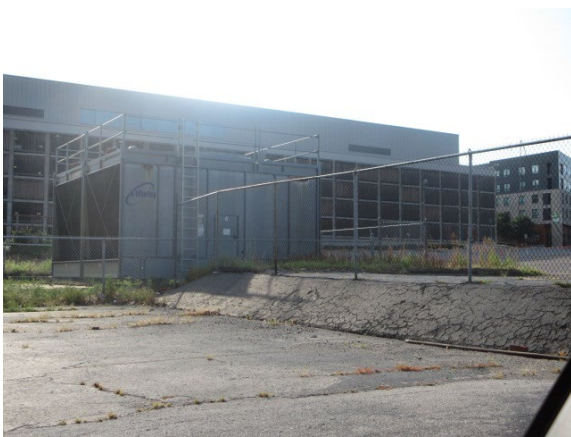
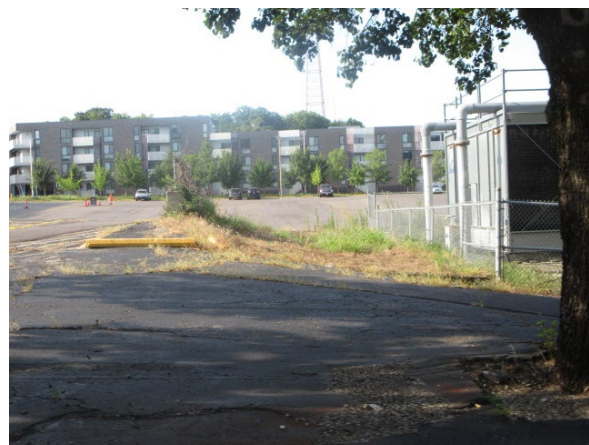
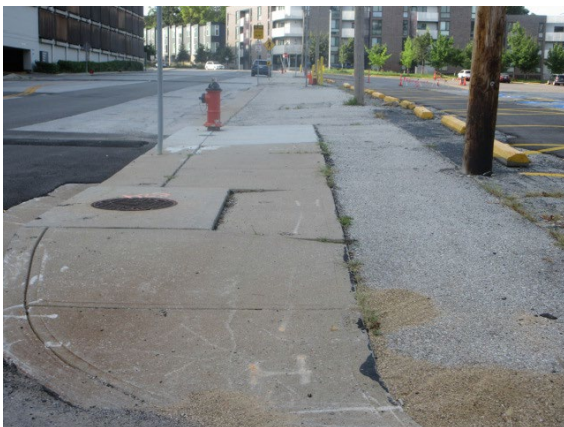
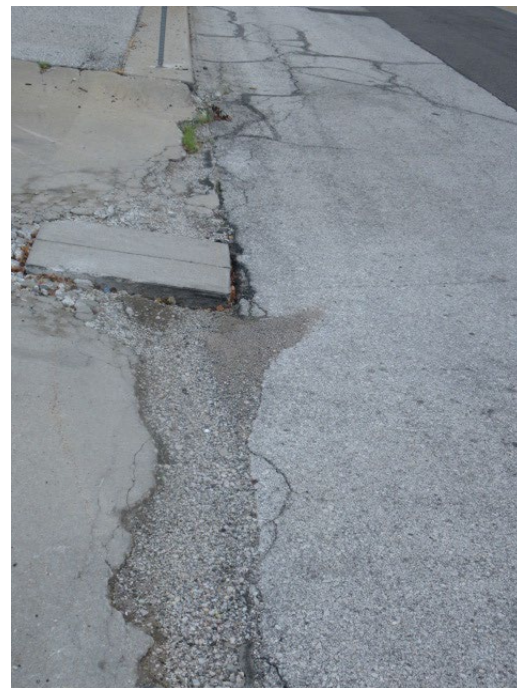
Dilapidated and decayed site improvement at the surface lot at 2601 Warwick and 401 E. 26<sup>th</sup> Street shown above and below.

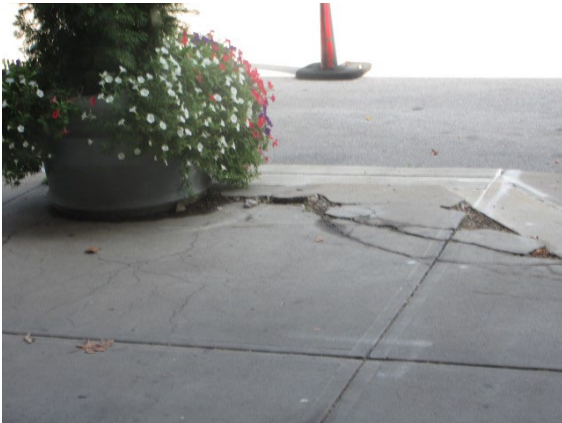
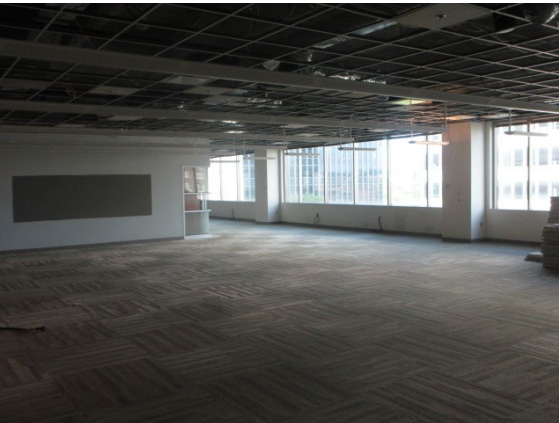
| <p>Dilapidated site improvement at the Westin.</p> | <p>Long vacant space at 2301 McGee. Extensive buildout required.</p> |

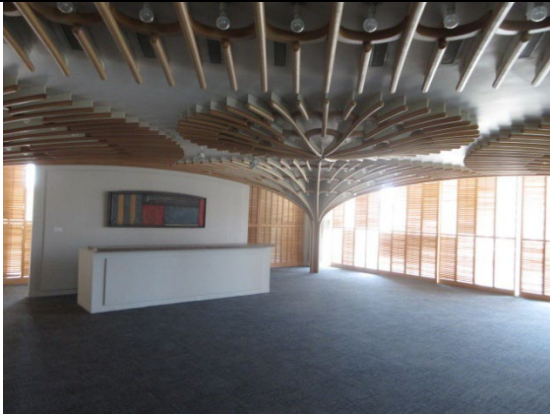
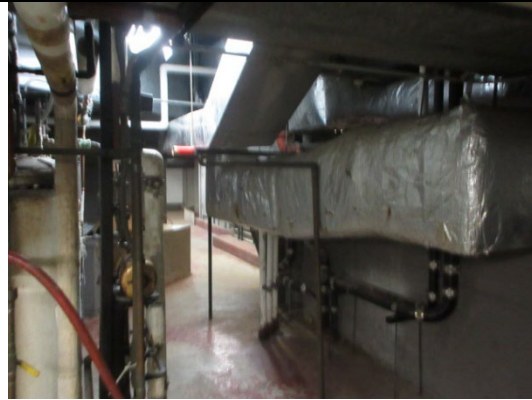
The photos above depict dilapidation in the former American Restaurant.

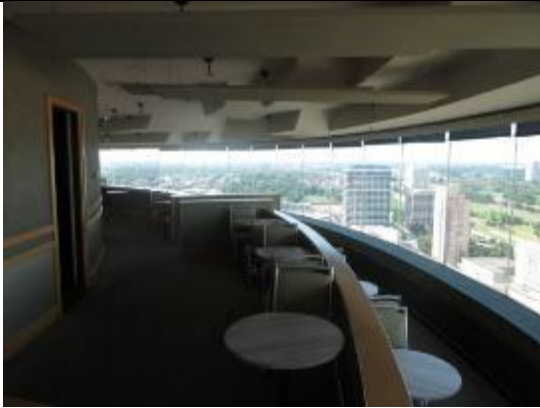
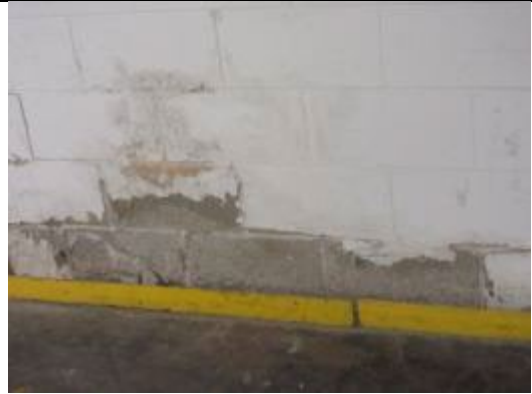
The interior finish at Skies is dilapidated and unusable

Dilapidated load bearing concrete retail parking Sheraton Garage.

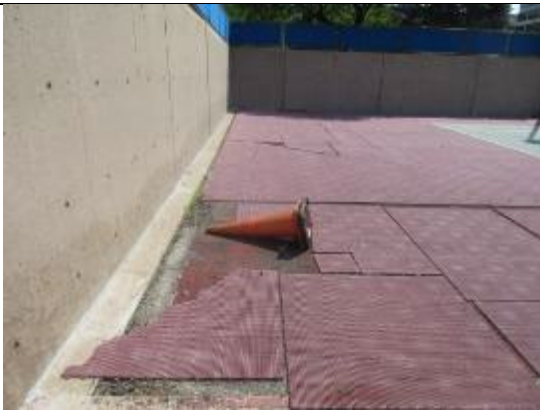
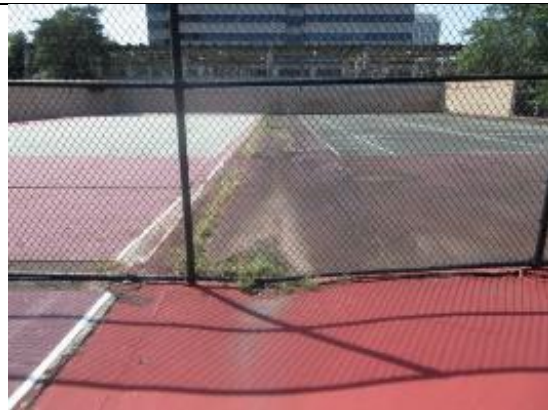
Shown above is an example of dilapidation at the outdoor common area for San Francisco Towers and Santa Fe Condominiums.

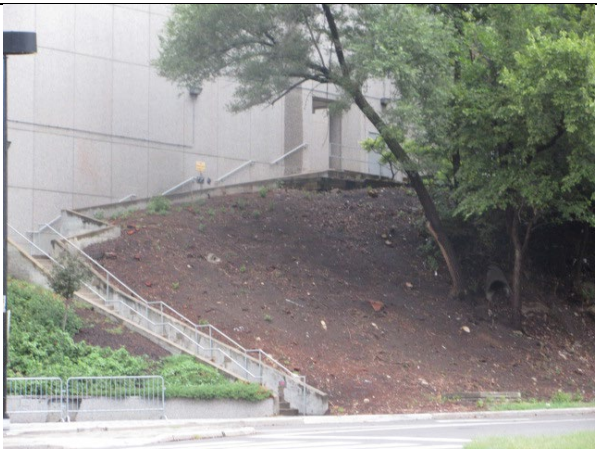
| <p>Dilapidated site improvements along Pershing near the Sheraton.</p> | <p>Site improvements along Gillham near the Sheraton have instances of dilapidation.</p> |

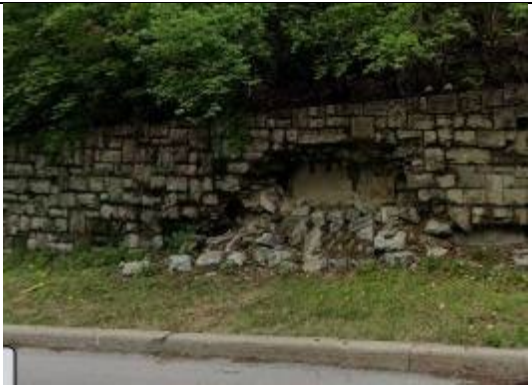
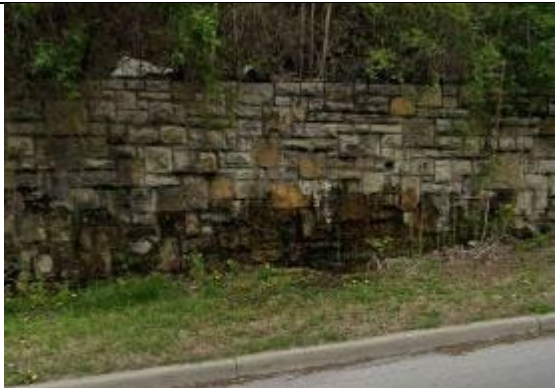
| <p>Within the public right-of-way the retaining wall between Gillham and Pershing near the Sheraton Hotel is dilapidated.</p> | |

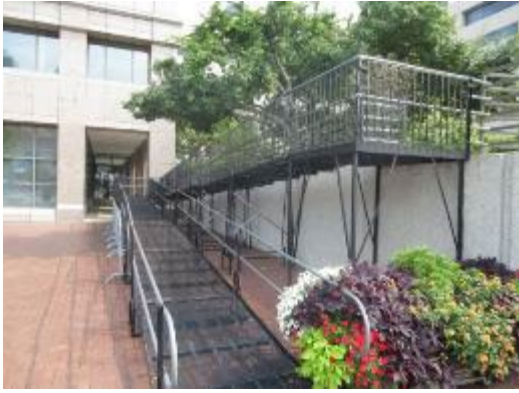
| <p>Poor ADA access at Crown Center Square Garage. Most older structures in the study area will not practically accommodate ADA compliant renovations.</p> | <p>Perimeter heating at the Pershing Road Office Complex is difficult to zone and costly to repair.</p> |

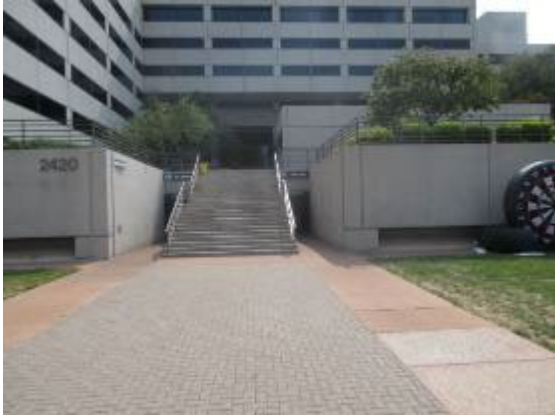
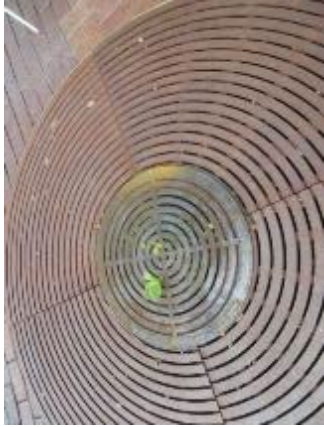
| <p>Nearly all landscaped and hardscaped area within Crown Center, from 22<sup>nd</sup> south to 25th Street is built over parking garages. The watertight membrane and extensive additional drainage is prone to failure and costly repair, creating extraordinary common area expenses which tenants will not likely bear.</p> | |

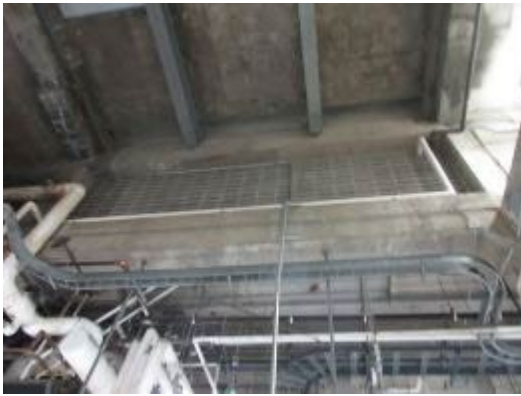
Central plant access is obsolete. HVAC equipment must installed and extracted through the street grates shown above both interior and exterior view.

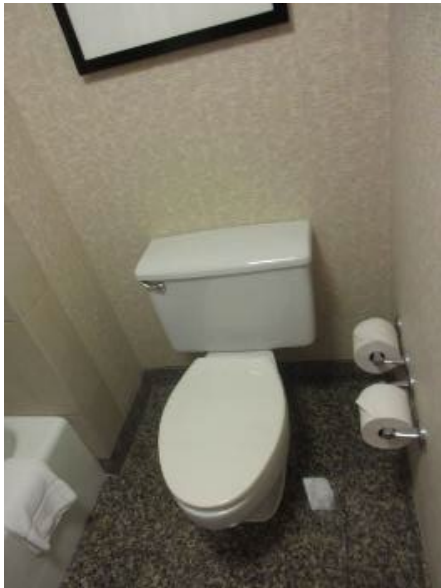
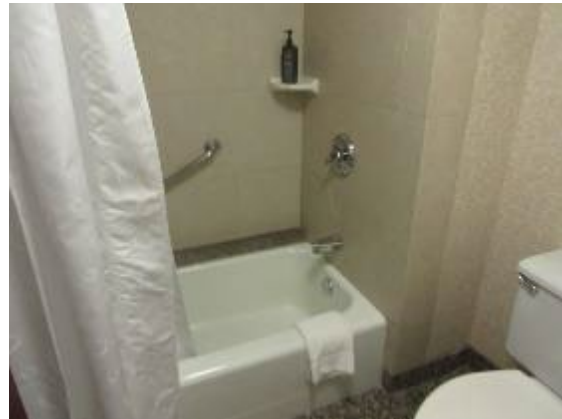
The Sheraton is 46 years old. It is in good condition overall and it's a favored asset of the owners. It is functionally obsolete by way of its guestroom plumbing. First are the combo tub and shower fixtures and tank toilets which are inconsistent with Marriott's requirements for the Sheraton brand. Second is the toilet plumbing. The room's socket over end vents create backup, odor and low pressure in the guestrooms and require extraordinary maintenance. Also the HVAC is largely original.

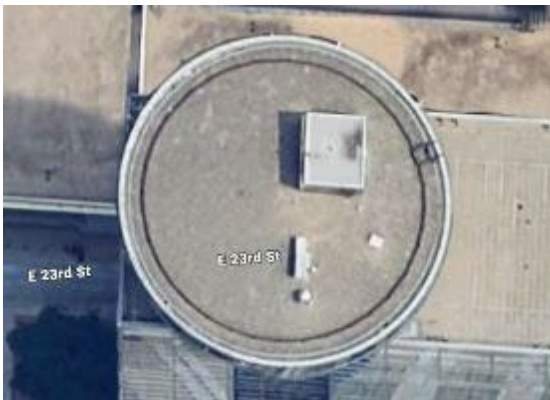
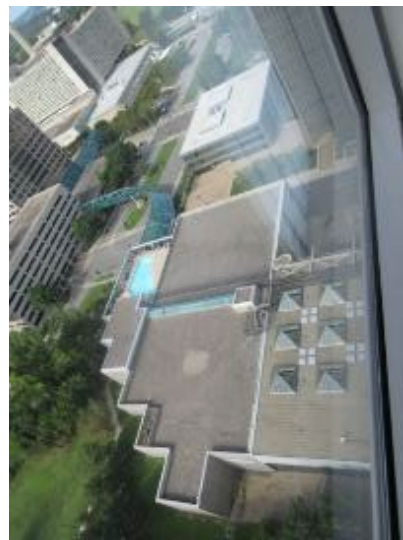
Other instances of obsolescence are the Sheraton's single pane windows and the revolving function at the former Skies Restaurant. The equipment required for operation is in disrepair and there are no replacement parts or service warranty available so its impractical to restart that Kansas City iconic attraction. And it is equally impractical to remove it.

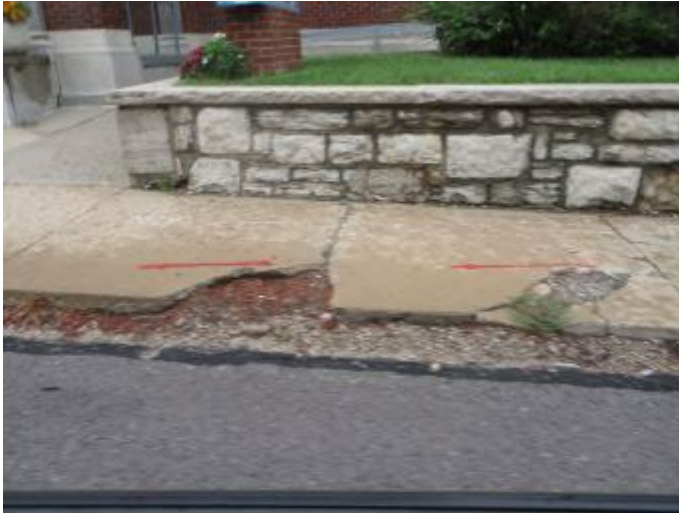
Deteriorated street improvements along Gillham.

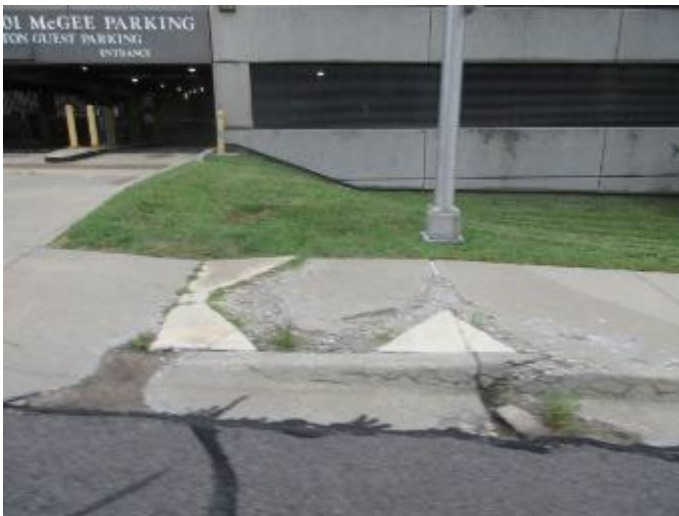
Sidewalk and drive to McGee Parking Garage

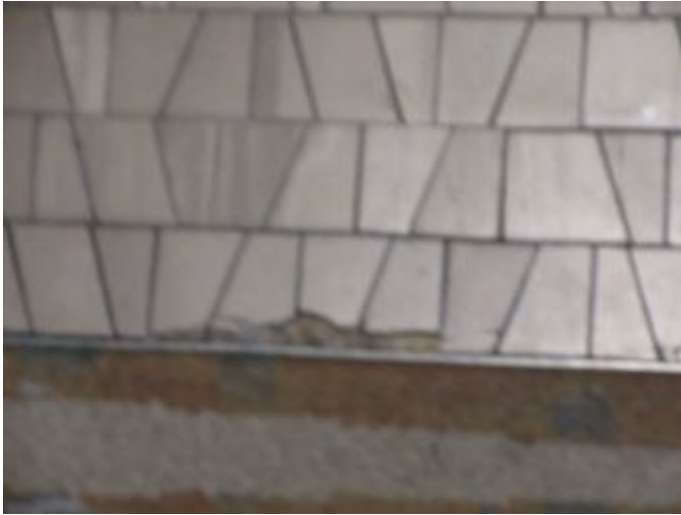
Deterioration of floor tiles at the Westin

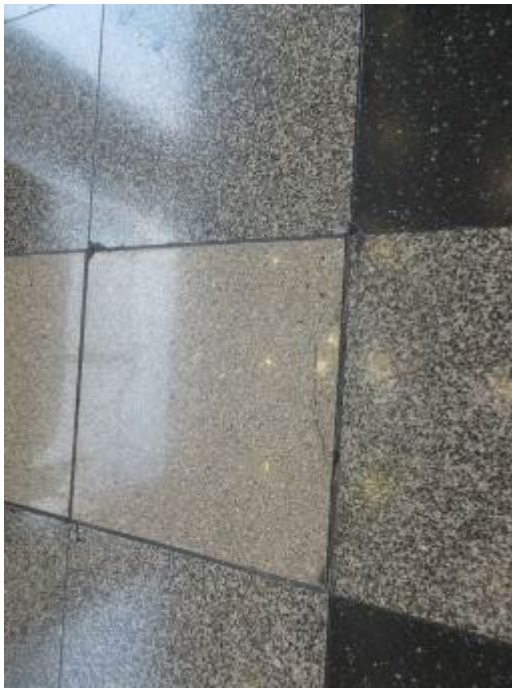
Floor tiles in the West Retail Building are failing at an unacceptable rate. And the tiles cannot be matched in color or texture. Replacement of the entire floor is imminent but retail tenants will experience significant disruption and lack of access during the process.

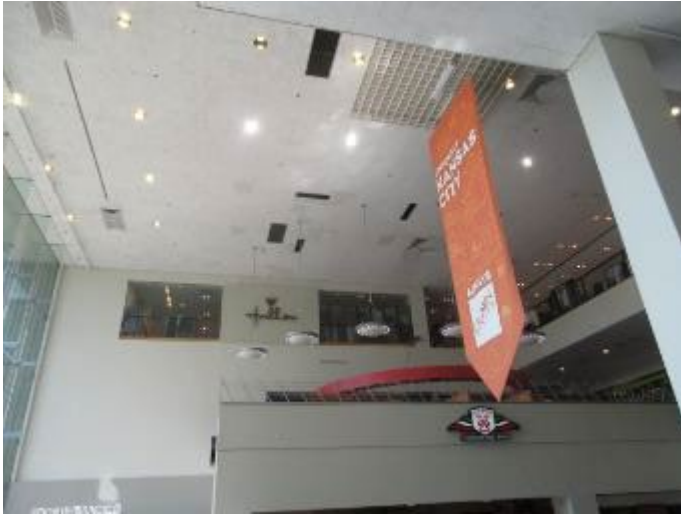
Likewise the ceiling in the West Retail building is nearing the end of its useful life. Most tenants and patrons will not notice the condition until the ceiling fails completely. Replacement is expensive given the height of the ceiling in the atrium.

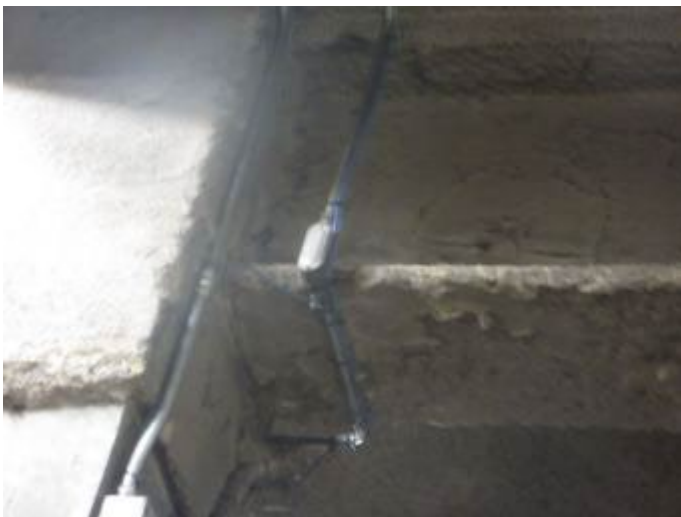
Deterioration in the parking garage serving West Retail.

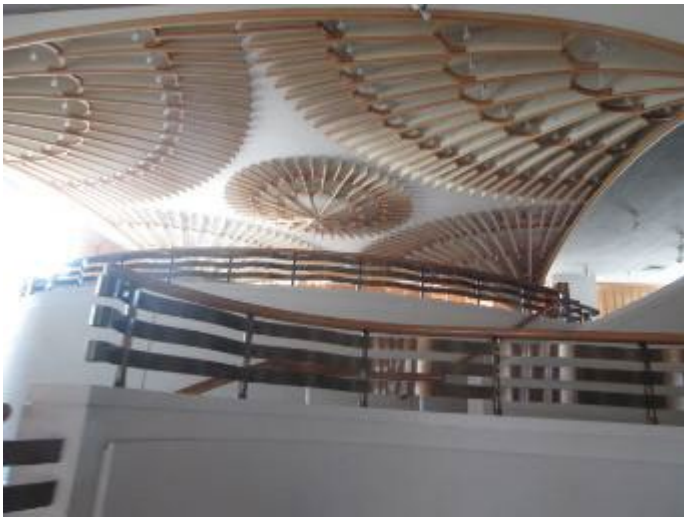
| | American Restaurant is over 10,000 square feet and has been vacant for approximately six years. This building is 23% vacant. |

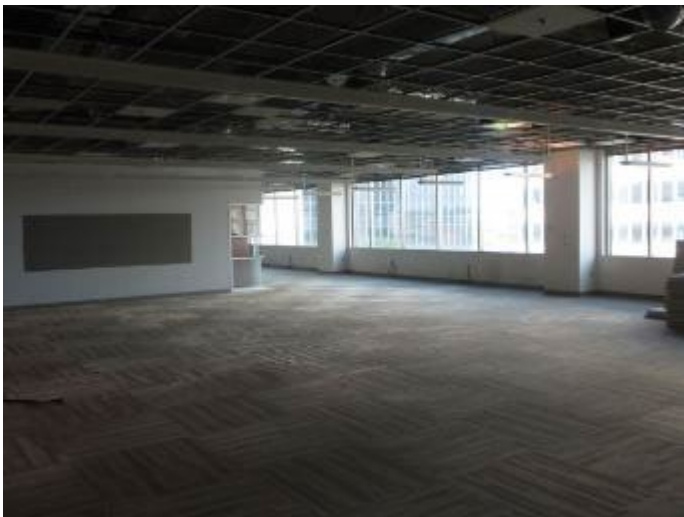
| | 2301 McGee is 38% vacant. |

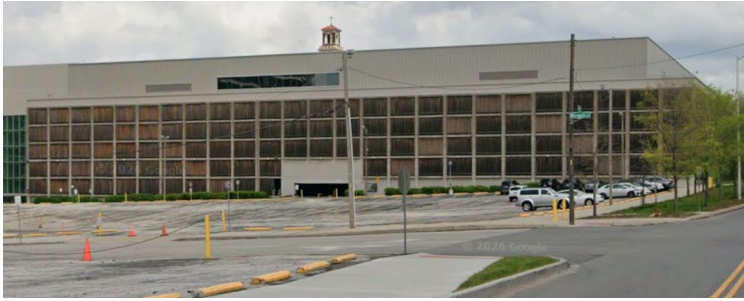
2615 McGee is the RIC building. It is mostly parking but there is 185,000 SF net rentable area which is completely vacant.

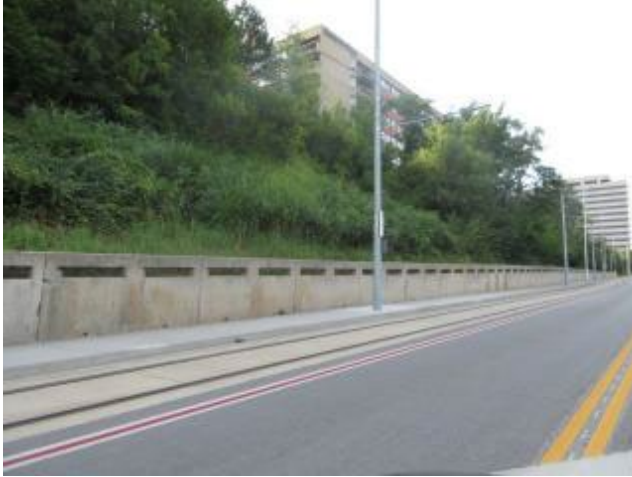
The Streetcar Route is adjacent to the study area for a 0.8 mile stretch, yet there is no retail or service oriented use directly visible and easily accessible from the Streetcar. While it is visually attractive, pedestrian and rider amenities are missing. The study area frontage along the streetcar is approximately 7% of the entire route. Given the Streetcar investment, the absence of street retail, usable green space, and good pedestrian access from Main Street directly to the West Retail reflects a lack of community planning.
